Idmiston Parish Council

Flood Risk & Sewers Study

S14-169
May 2015

Revision 3

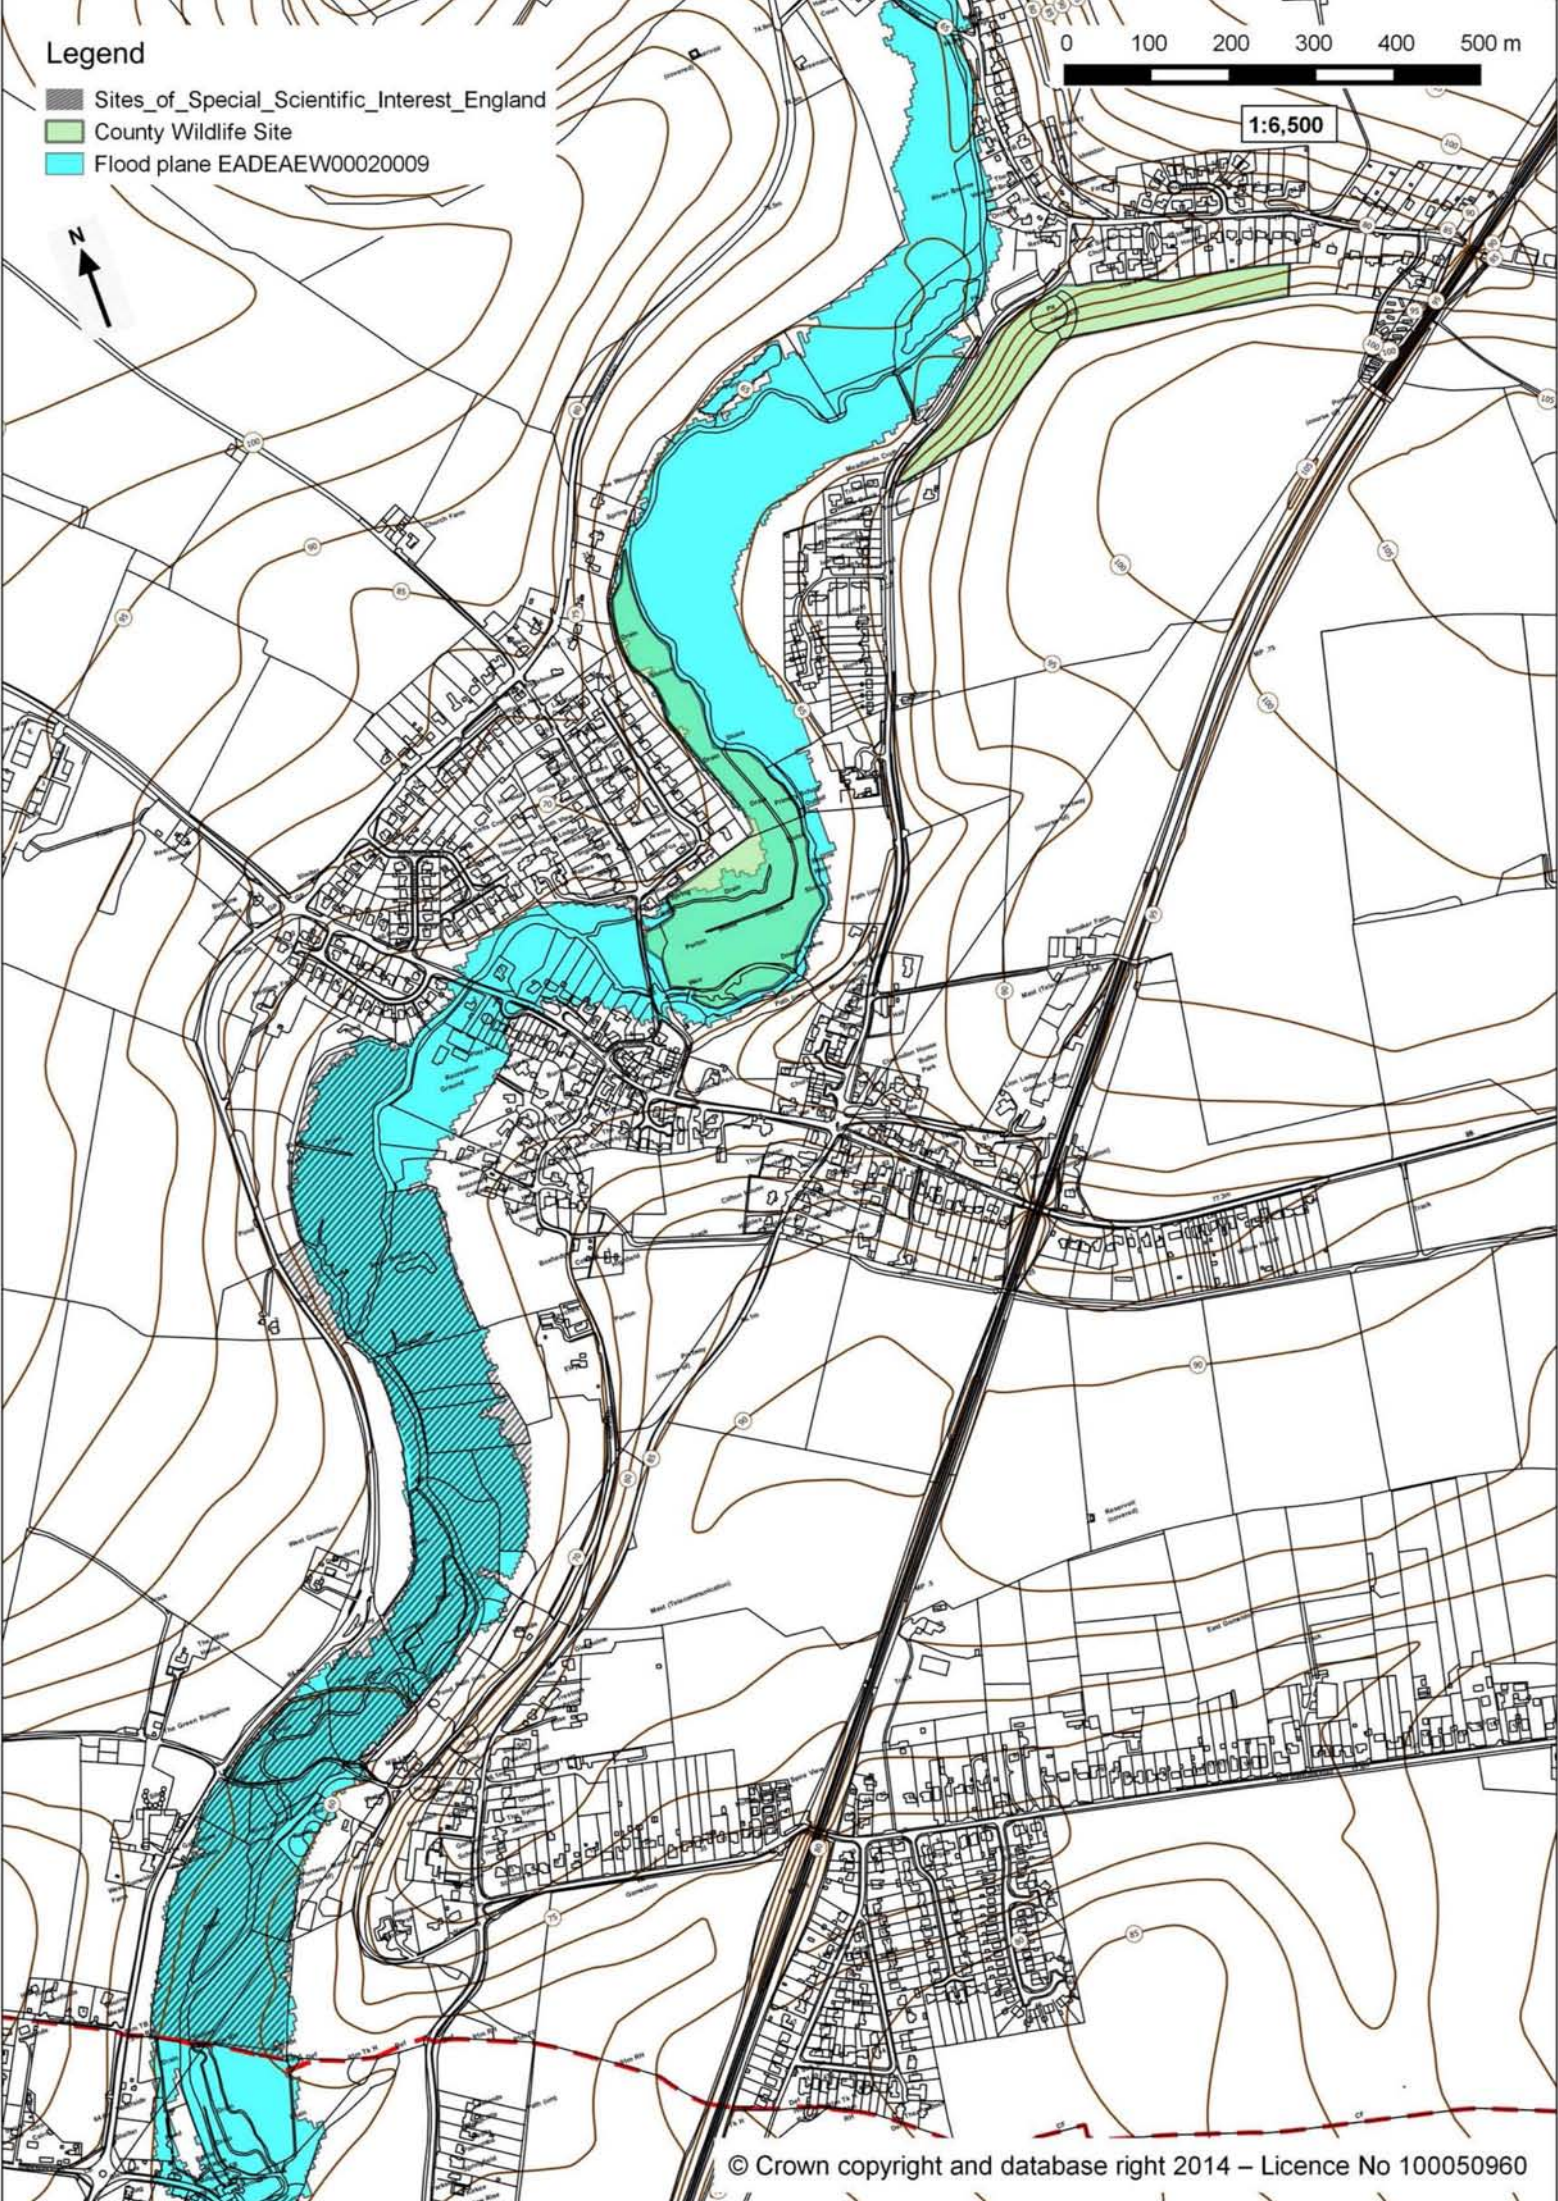
Best guess so far at surface water drainage in Porton village

- Thought to exit via the outfall behind Byford Gardens
- High Street drains head North to reach the River Bourne

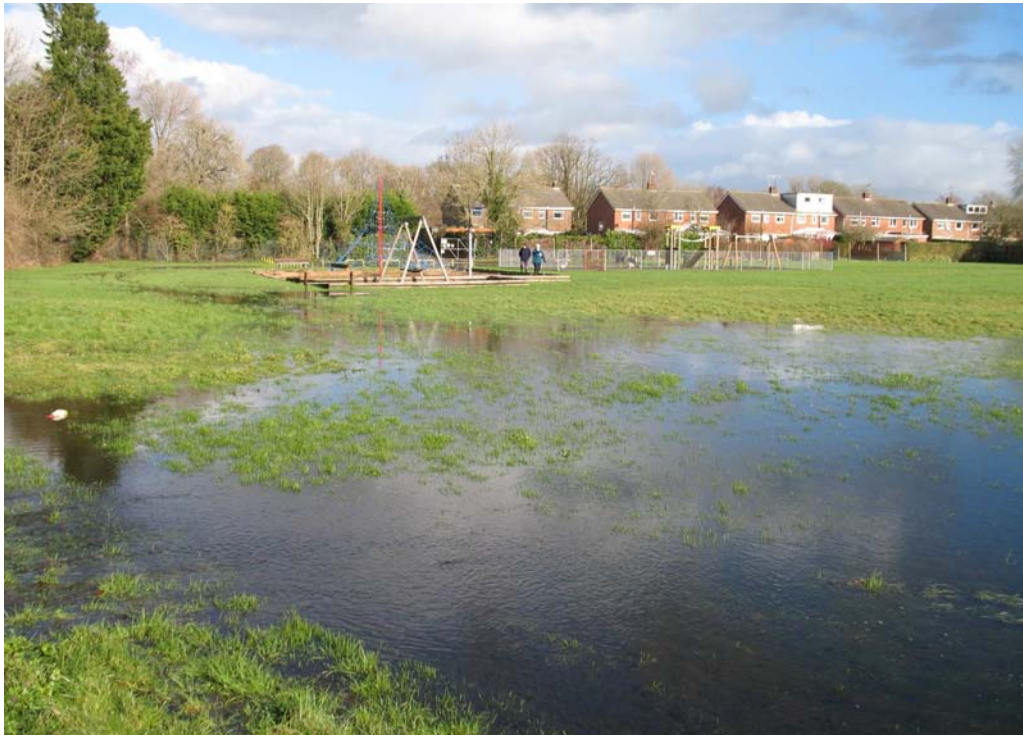
The flood plain had remained largely undeveloped but some encroachment has occurred in Porton, adjacent to the recreation ground. Indeed recent flooding saw the properties fronting on to Winterslow Road flooded. Please see photos in **Appendix 5**.

Porton - The Recreational Area and Childrens Playground are situated with Flood Zone 3, it is thought that risk level to individuals is acceptable, but there is amenity loss for a significant percentage in a given year owing to water-logging and flooding.

1 -Flooding of the Recreation Ground

A land raising scheme in the recreation ground may prove applicable, and perhaps profitable. Use of suitable sub-soil wastes imported under a relevant environmental permit could raise ground levels above typical flood levels, extending usage through winter months. It is likely that this work would fund itself owing to revenues generated from soil imports. This would however detract from the flood storage volume of the flood plain, and so this would have to be carefully considered. Consultations with the Environment Agency recommended.

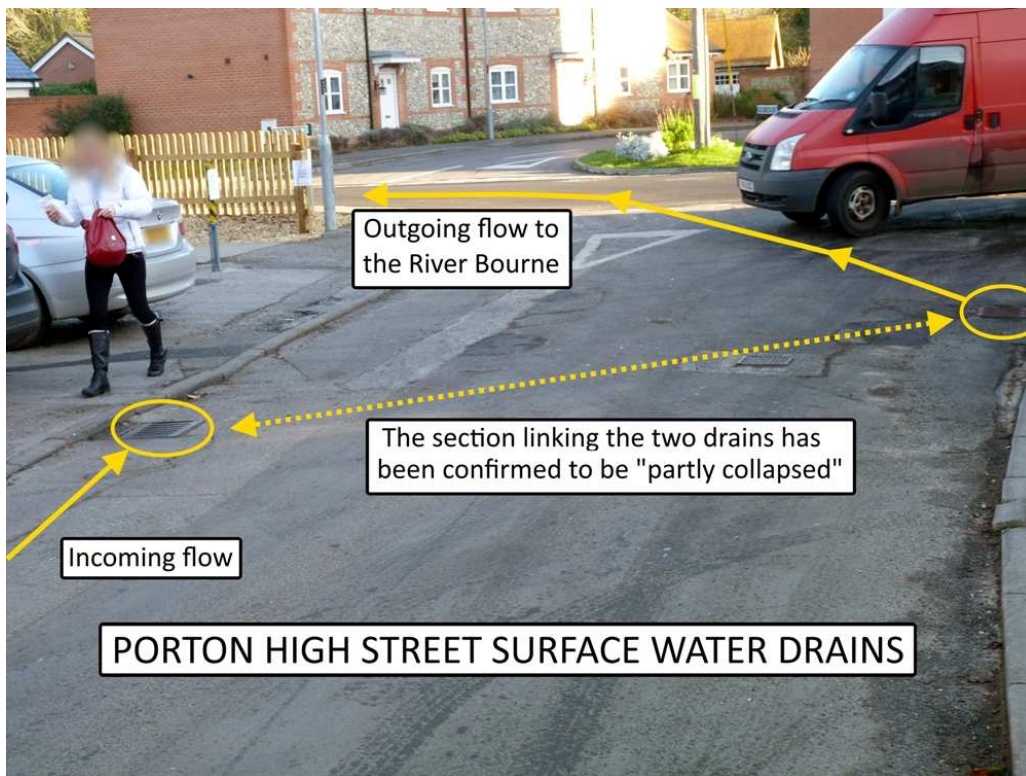
2—High Street looking towards Byford Gardens

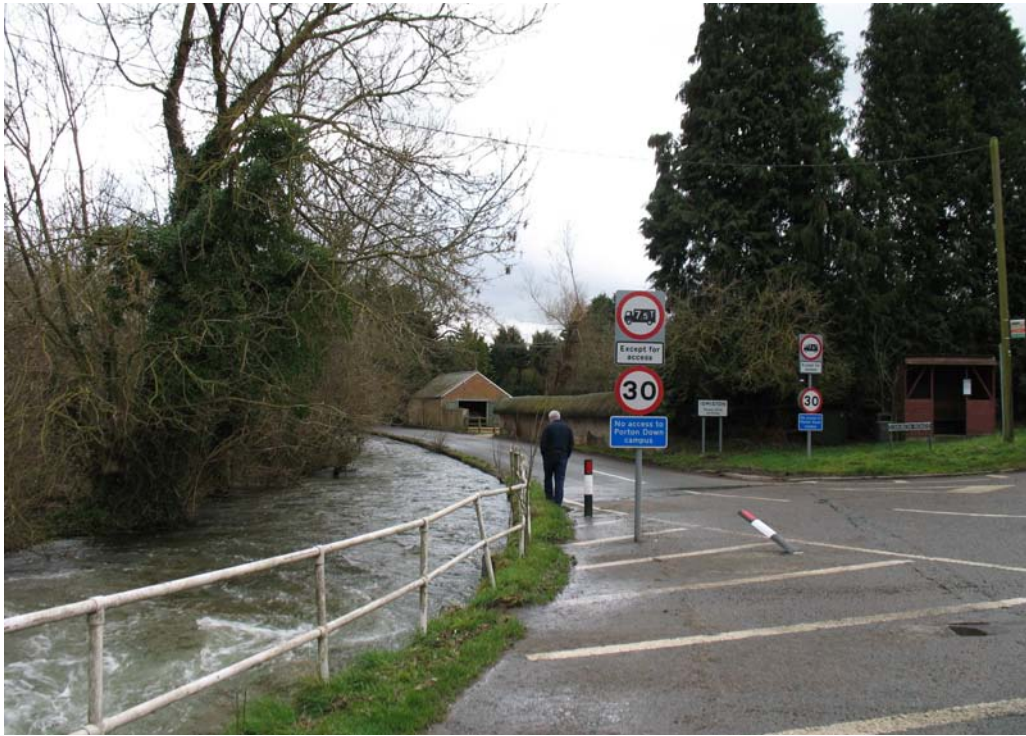
Idmiston – There are properties on the western side of Church Road which are sited adjacent to the River Bourne whose curtilage extends in some cases in to Flood Zone 3. With increasing intensity of rainfall anticipated owing to global warming (20% - 30%) by 2112, risk to these properties will increase over the coming decades.

3—River Bourne adj. Church Lane

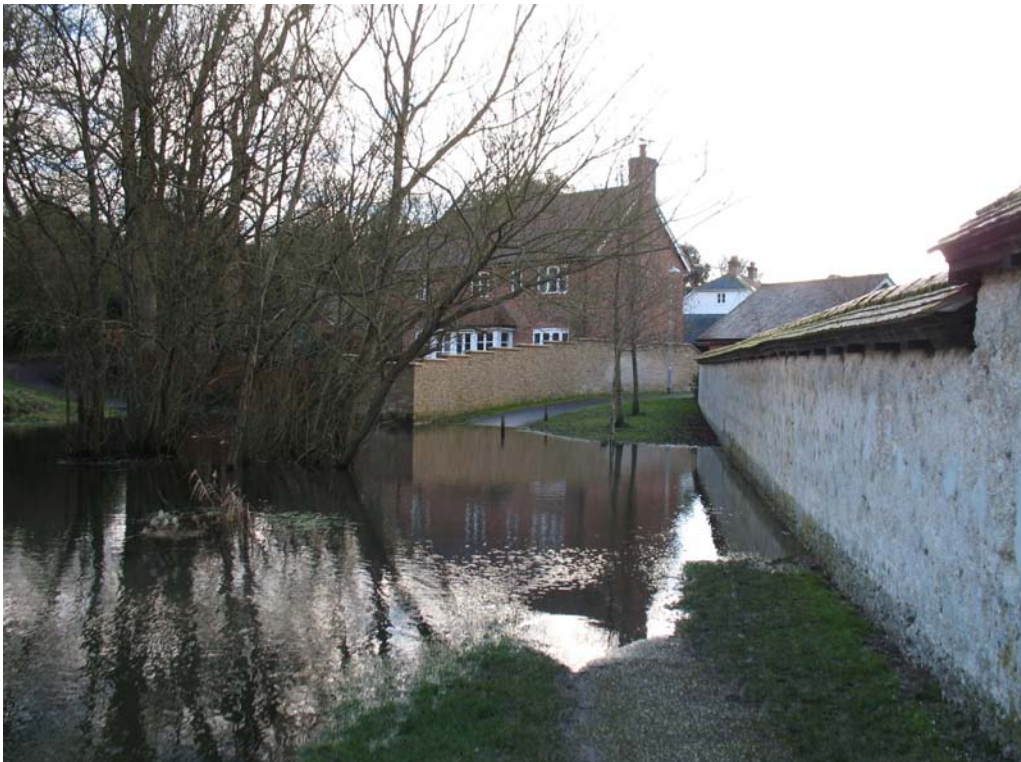
It was observed that Byford Gardens (Porton) has a dedicated surface water sewer system, which feeds in to the River Bourne. This surface water sewer remains un-adopted and outlets were observed to be heavily silted.

Surface water from highways is either dealt with by soak-away drainage systems, or unmapped sewer systems. Conditions of these sewers are varied as was illustrated by the dilapidated state of the Byford Gardens outlet at the time of initial survey.

4—Water Levels rear Byford Gardens

Wiltshire Highways have made noticeable efforts (January 2015) in the improvement of the Byford Gardens Surface Water Outfall (**Appendix 5**). Wiltshire Highways have verbally advised that repairs to a collapsed surface water drains adjacent the Village Shop (High Street) will have to be undertaken at some point in the near future.

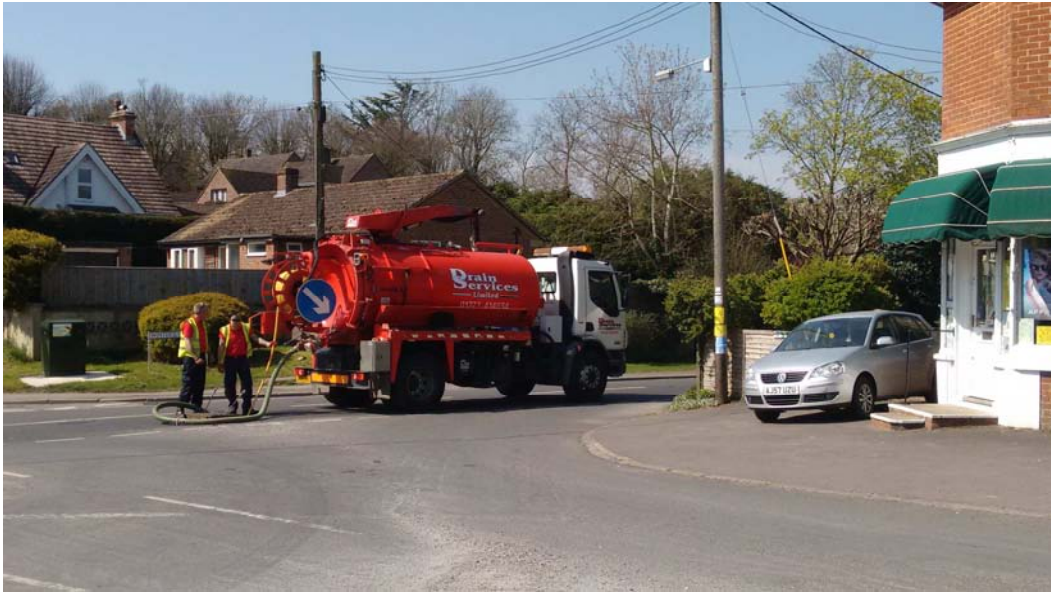
Porton – Highway Surface Water Drains were noted to be in a poor state of maintenance at the time of site visit, particularly on Winterslow Road to the East of the Railway Line. Again drains were heavily silted in Porton Village Centre.

Regular vacuum tanker visits have noted in the vicinity of the Porton High Street during March and April.

5— Frequent cleaning of drains and gullies may suggest siltation problems with drains in Porton High Street.

Porton – Highways Surface Water Drains were noted to be in a poor state of maintenance at the time of site visit, particularly on Winterslow Road to the East of the Railway Line. Again drains were heavily silted were observed to be heavily silted in the village centre. Regular clearing of these drains is essential in order to keep risks from surface water flooding low.
