Idmiston Parish Council

Flood Risk & Sewers Study

S14-169
May 2015

Revision 3

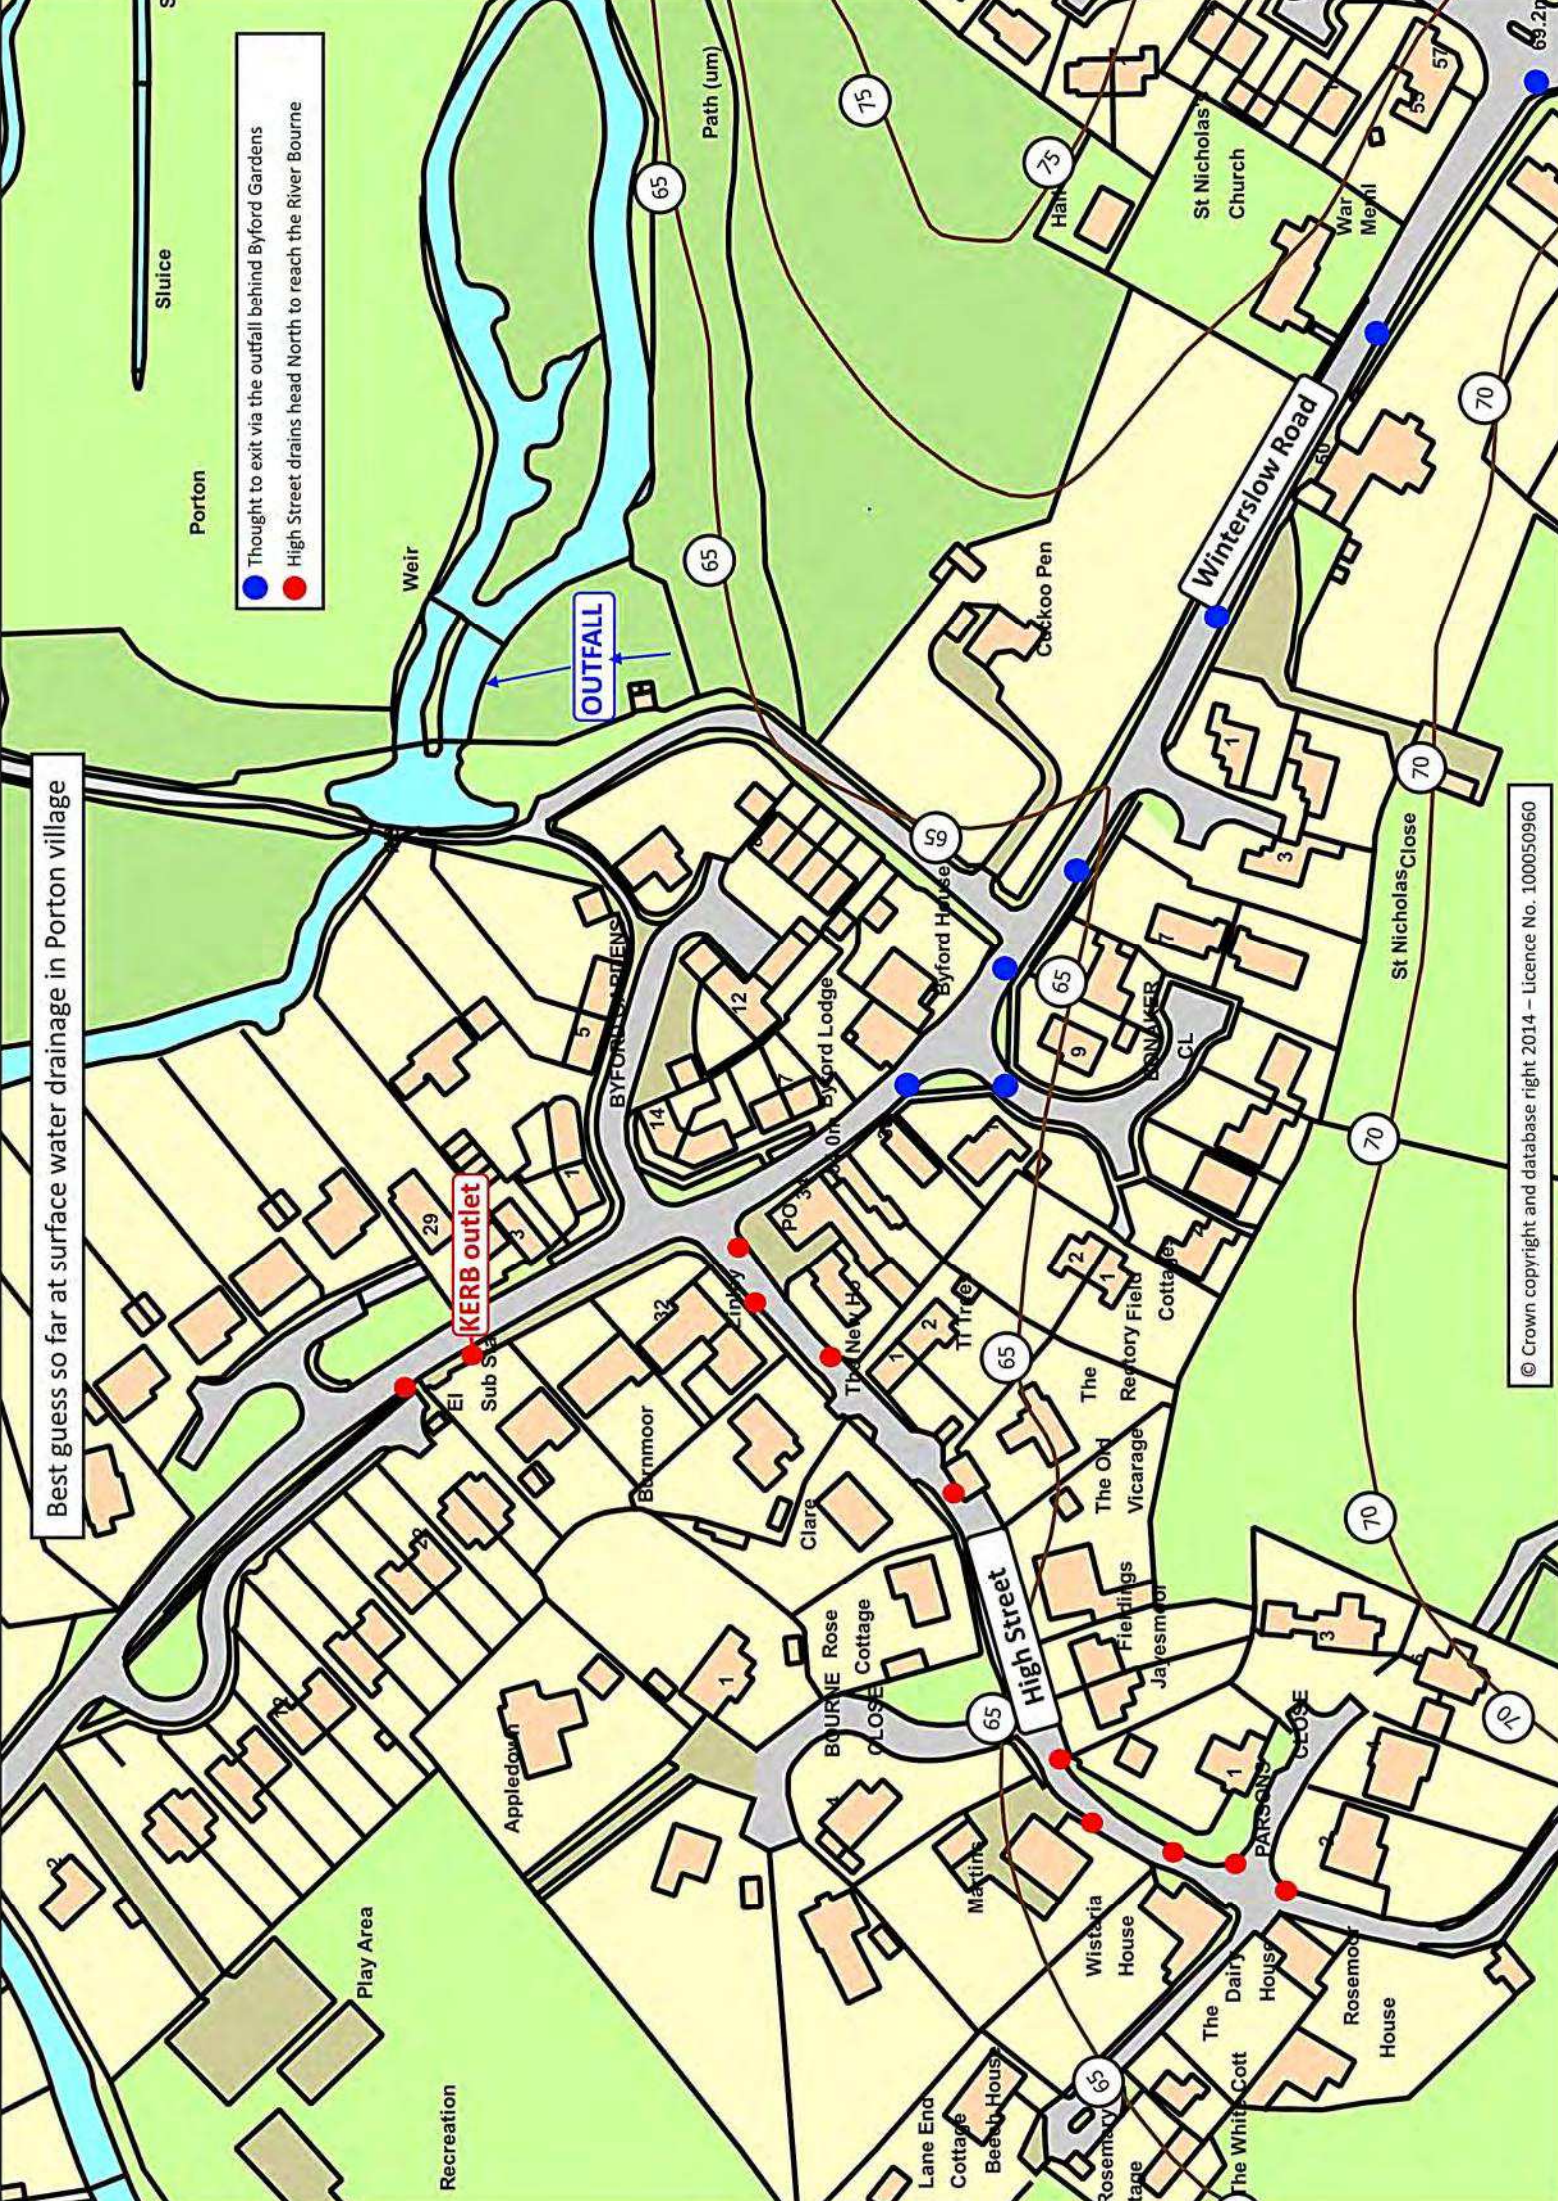
Best guess so far at surface water drainage in Porton village

- Thought to exit via the outfall behind Byford Gardens
- High Street drains head North to reach the River Bourne

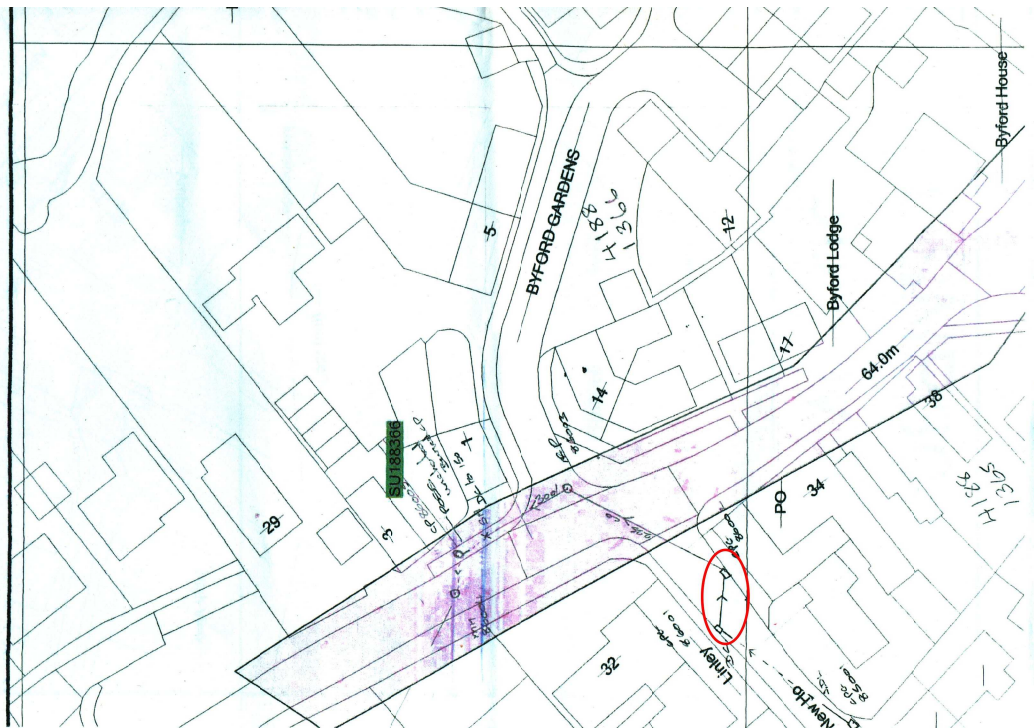
5— Frequent cleaning of drains and gullies may suggest siltation problems with drains in Porton High Street.
